CONNECTICUT RIVER BASIN
MONSON, MASSACHUSETTS

ZERO MANUFACTURING COMPANY DAM
MA 00551

PHASE I INSPECTION REPORT NATIONAL DAM INSPECTION PROGRAM

APRIL 1981

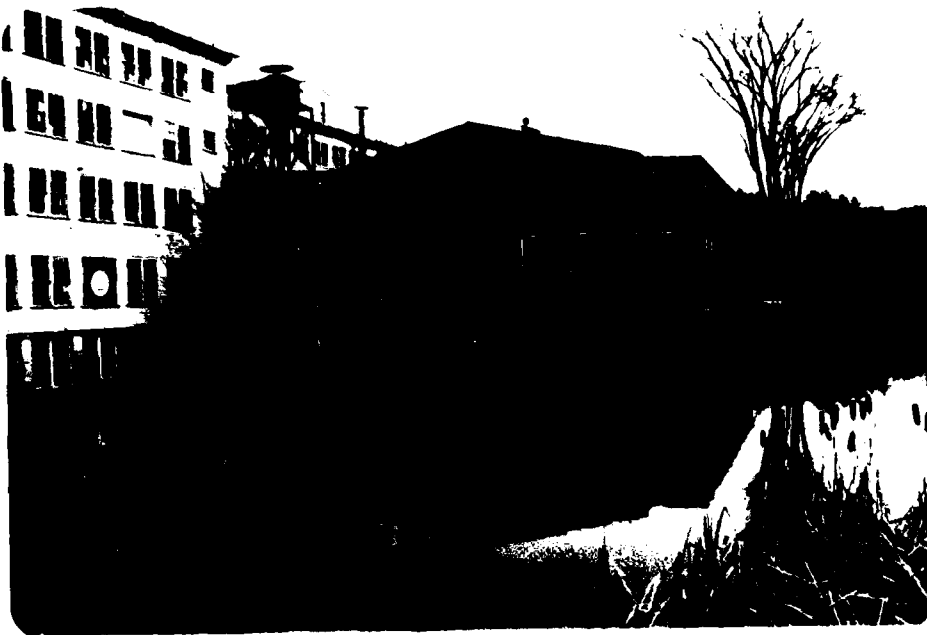
NO. 1 TOP OF DAM AT INTAKE AREA

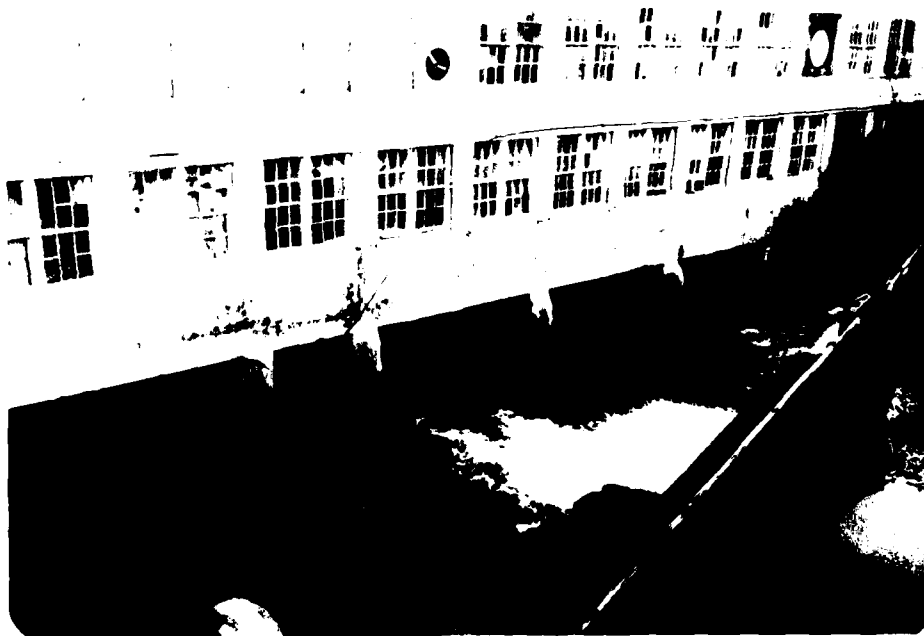
NO. 2 STRUCTURE OVER CHICOPEE BROOK DOWNSTREAM
OF SPILLWAY

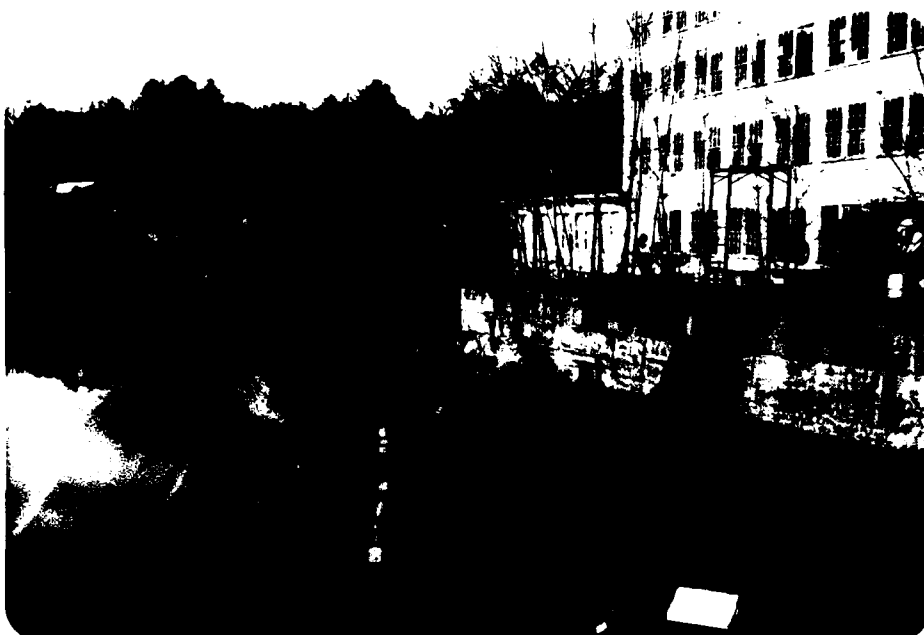
**NO. 5 INTAKE AREA — HAND WHEEL OPERATORS FOR LOW
LEVEL OUTLET AND WATER SUPPLY PIPES**

- a. Operating and Maintenance Procedures. It is recommended that the Owner accomplish the following:
 - (1) Repair the operating mechanism on the low-level outlet and on Outlet No. 3 to restore them to working condition. Investigate a means of sealing Outlet No. 2 at the upstream end, so as to remove pressure in the conduit.

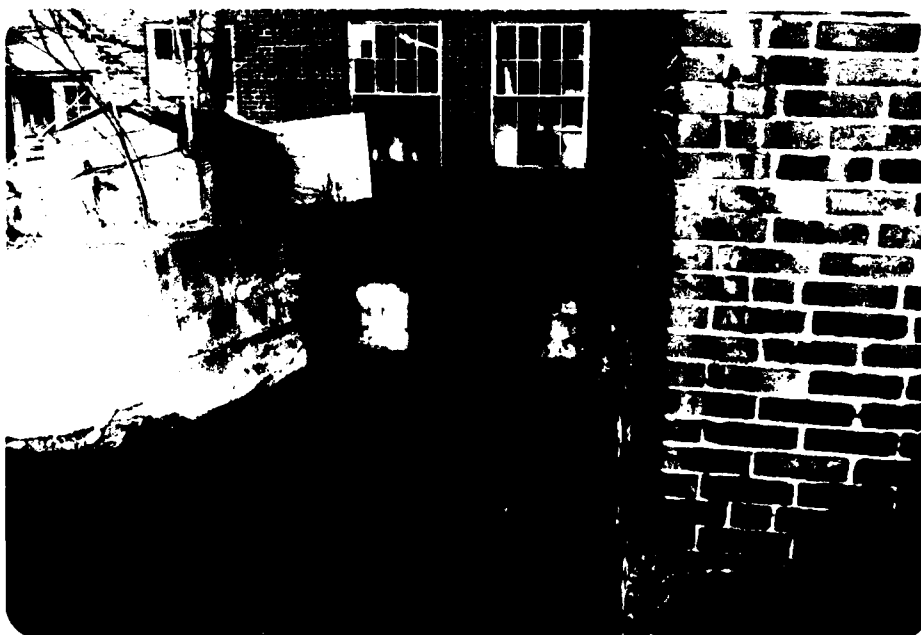
**NO. 6 INTAKE AREA — CONTROL MECHANISM FOR SLIDE
GATE**
